Past, Present, Future Erosion at Locke Island

Hanford Cultural Resources Project

B. N. Bjornstad

June 2006

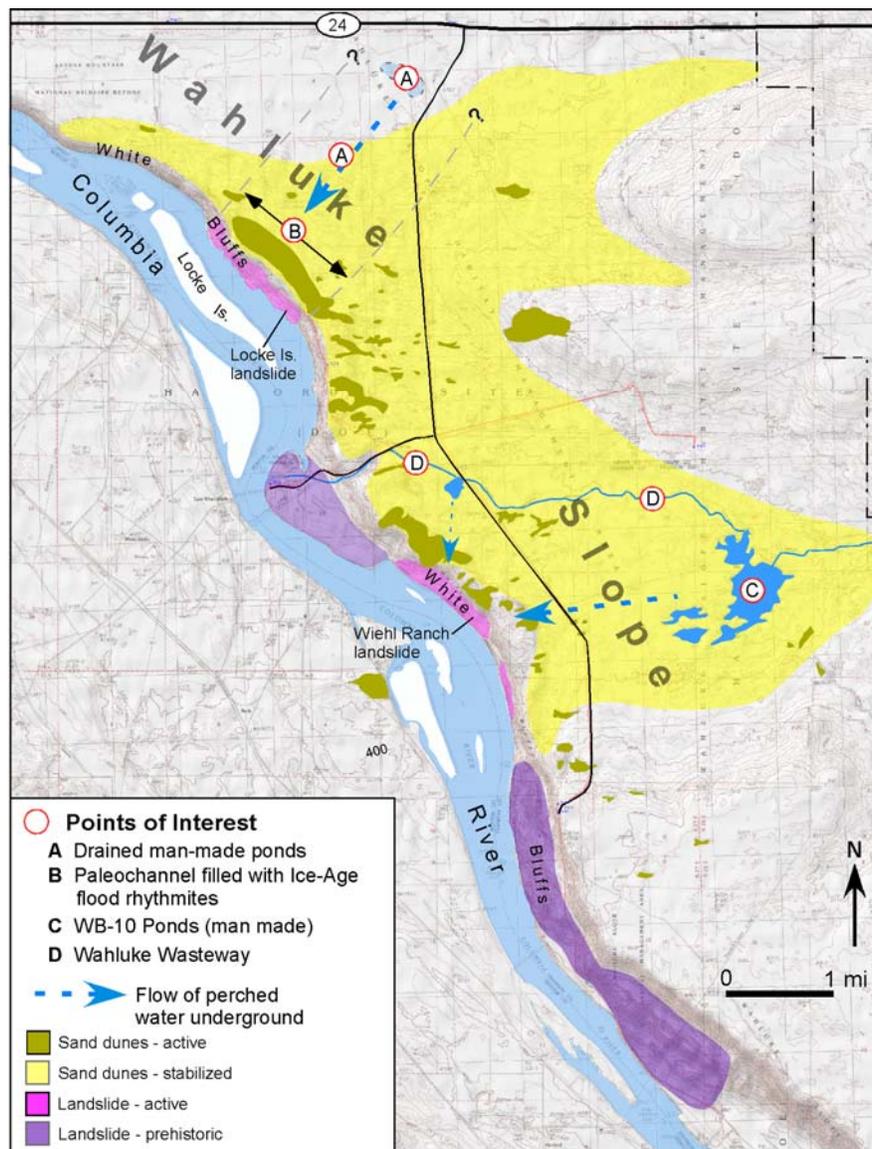
Figure 1. Map Showing Sources of Water That Initiated Modern Landslide Movements Along the White Bluffs (Bjornstad 2006)

face. Because underground seepage naturally flows along the base of the paleochannel, it is not a coincidence that the ~1-mile width of the active landslide is exactly the same width as the paleochannel (Figure 1). Here, where the ground is saturated, the wet, soft sediments of the Ringold Formation lose much of their internal strength, leading the bluffs to slump. Slumping began in the late 1970s and continues today, even though the ponds (“A” in Figure 1) were completely drained in the mid-1990s in an attempt to stop the sliding. The rate of movement at the toe of the landslide has gradually slowed from as much as 20 ft/yr in 1998 to the point where there has been little or no detectable movement in recent years.

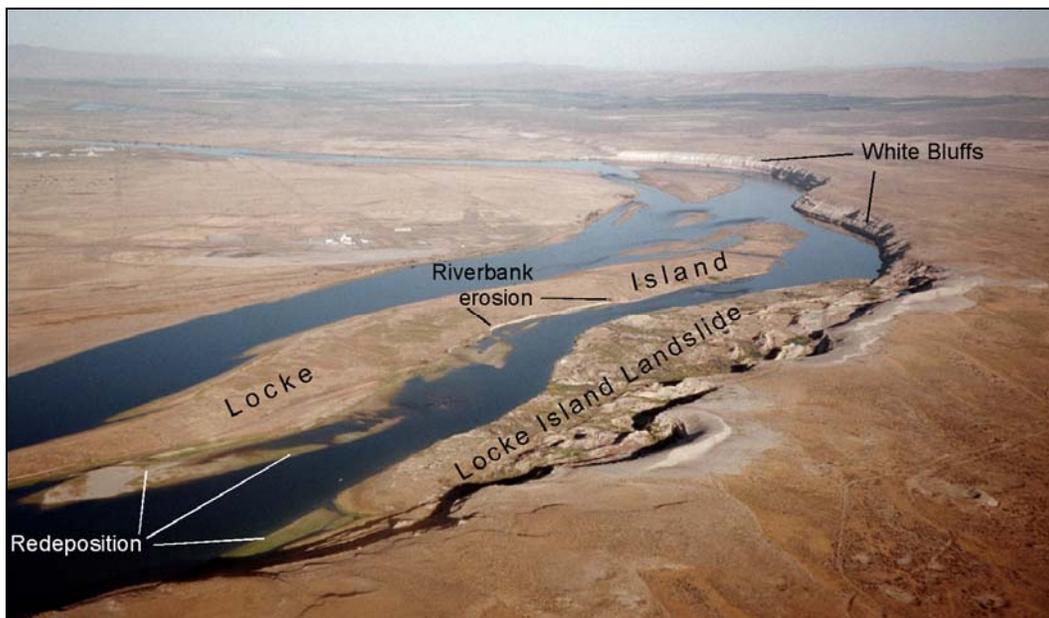
Figure 2. Aerial View of Locke Island (looking West) Taken September 2001 Showing Extent of Riverbank Erosion Due To Locke Island Landslide (The most extensive erosion of the island occurs where the steep, fresh, riverbank face is exposed. Eroded sediment from the island as well as the landslide is being redeposited just downstream from where the river widens, current slows, and sediment settles out of suspension. Bob Peterson photo.)

Movement of the landslide has narrowed the river channel and shifted it southwestward. Furthermore, the river is forced to flow more rapidly around the outside of the curve in the river created by the landslide. This has focused the river’s energy to the northeast bank of Locke Island, causing considerable undercutting and erosion (Figures 2 and 3). Sediments calving away from the steep riverbank consist of mostly fine-grained, Holocene-age, overbank alluvial deposits of the Columbia River (Bjornstad and Cadoret 1997). These deposits contain ancient cultural artifacts and remains (Nickens et al. 1998).

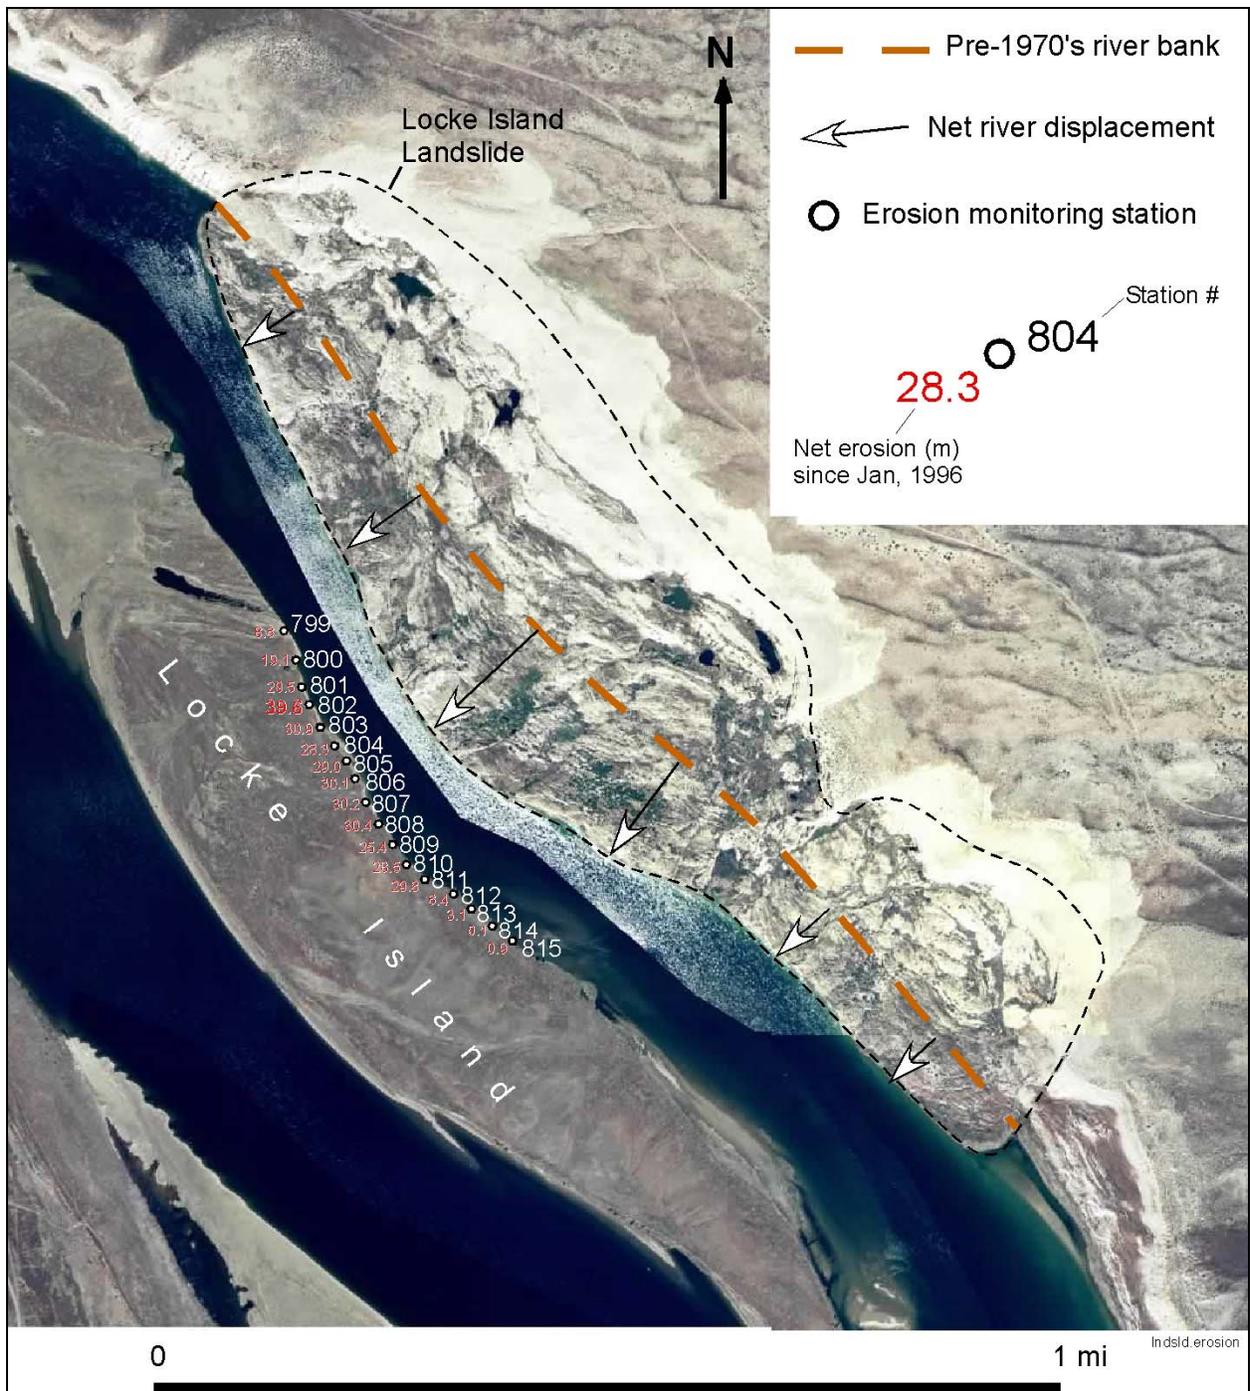
Figure 3. Most Recent Aerial Photograph, Taken in 2002, of Locke Island and the Locke Island Landslide Complex (Erosion monitoring transects are indicated in white and total erosion since 1996 is indicated in red. The Columbia River flows from upper left to lower right.)

A sequence of aerial photographs shows the initiation and growth of the Locke Island Landslide over the years since the first image was collected in 1941 (Figure 4). The entire series of images is presented in Nickens et al. (1998) and USBR (1999). In the photographs, the bluffs begin to slump in the mid-1970s and continue with accelerated growth of the landslide into 1982 when the last image was collected. Since these reports came out, a more recent aerial survey was performed (Figure 3). Historical aerial photos show slumping that starts across from the southeast end of Locke Island that worked its way northwestward. Most of the recent landsliding has occurred to the northwest, directly across from the middle portion of Locke Island (Figure 3). In 2002, it appears the landslide is still very well established and strongly influences flow of the river in the vicinity of Locke Island (Figure 3).

(Figure 3). Note that the maximum amount of erosion (almost 40 m at Station #802) has occurred just upstream of the narrowest part of the channel. Just upstream, in Figure 6 (top), is the freshly exposed riverbank, exposed by active slumping. Because of the venturi effect, the speed of the water here is greatest and capable of doing the most erosive work. The higher velocity of the river here is not only more effective at undercutting the northeast bank of the island but also at transporting away the slumped material, which leads to more slumping (Figure 6).

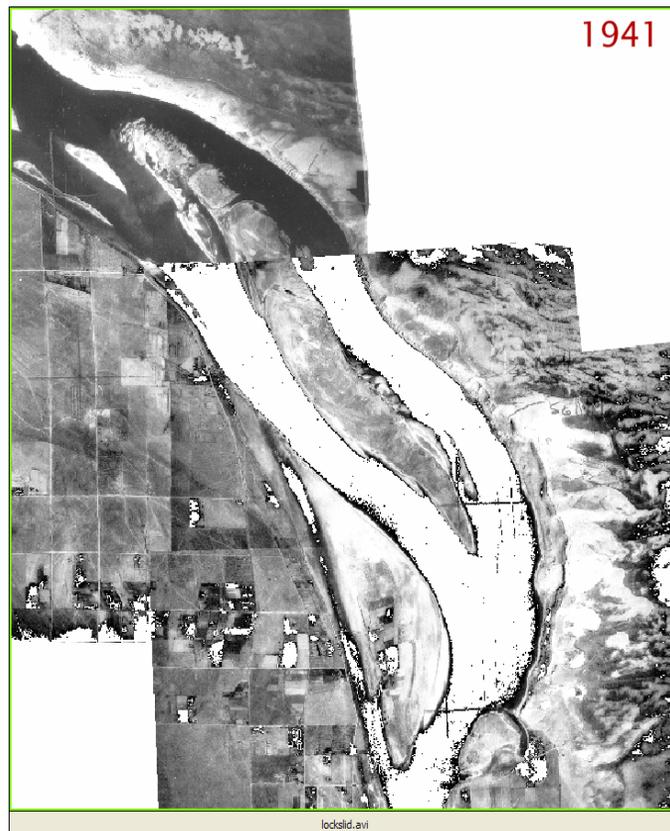
Figure 4. First Aerial Image of Locke Island Collected in 1941 (Notice there is little evidence of sliding, and in this image, the bluffs as well as Locke Island are completely intact.)

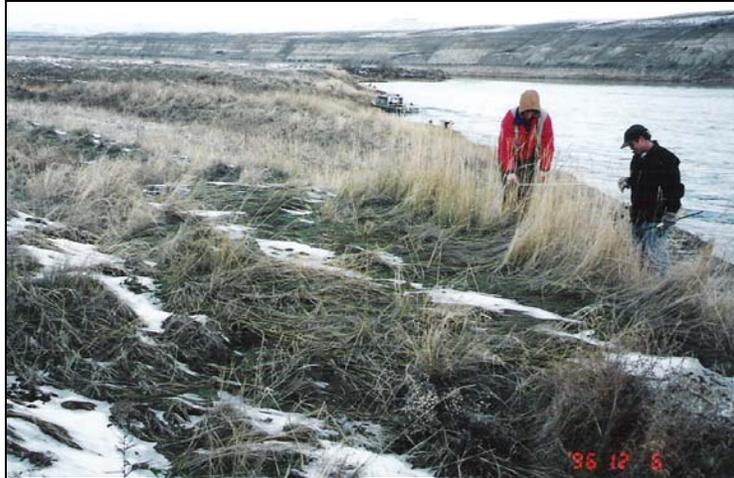
Figure 5. Measuring Amount of Riverbank Recession Within a Network of Surveyed Monitoring Stakes Placed in January 1996

Alarmed by the high rate of erosion taking place on Locke Island, PNNL scientists installed a series of transects in 1996 along the northeast side to identify the location and rates of erosion (Figure 5). The transects were placed directly across from the landslide in the area where fresh faces of the island were being exposed as slump blocks calved into the river (Figure 6).

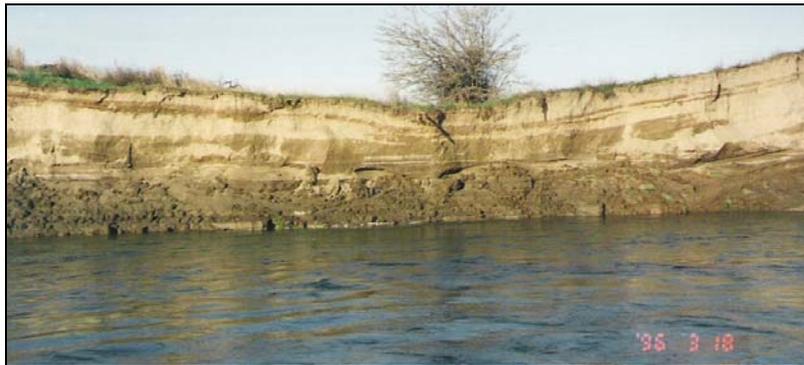
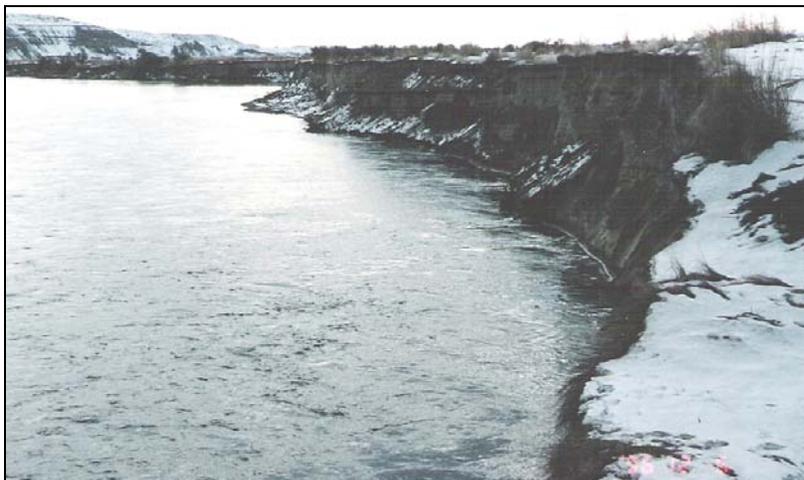
Figure 6. Northeast Bank of Locke Island Exposed Via Undercutting by the River (Upper photograph, taken in mid-March 1996, shows slumped debris at base of steep cut bank that is transported away during high water (lower photo), which saturates and loads the stream bank. During a sudden, rapid drop in river level, more slumping is likely to occur.)

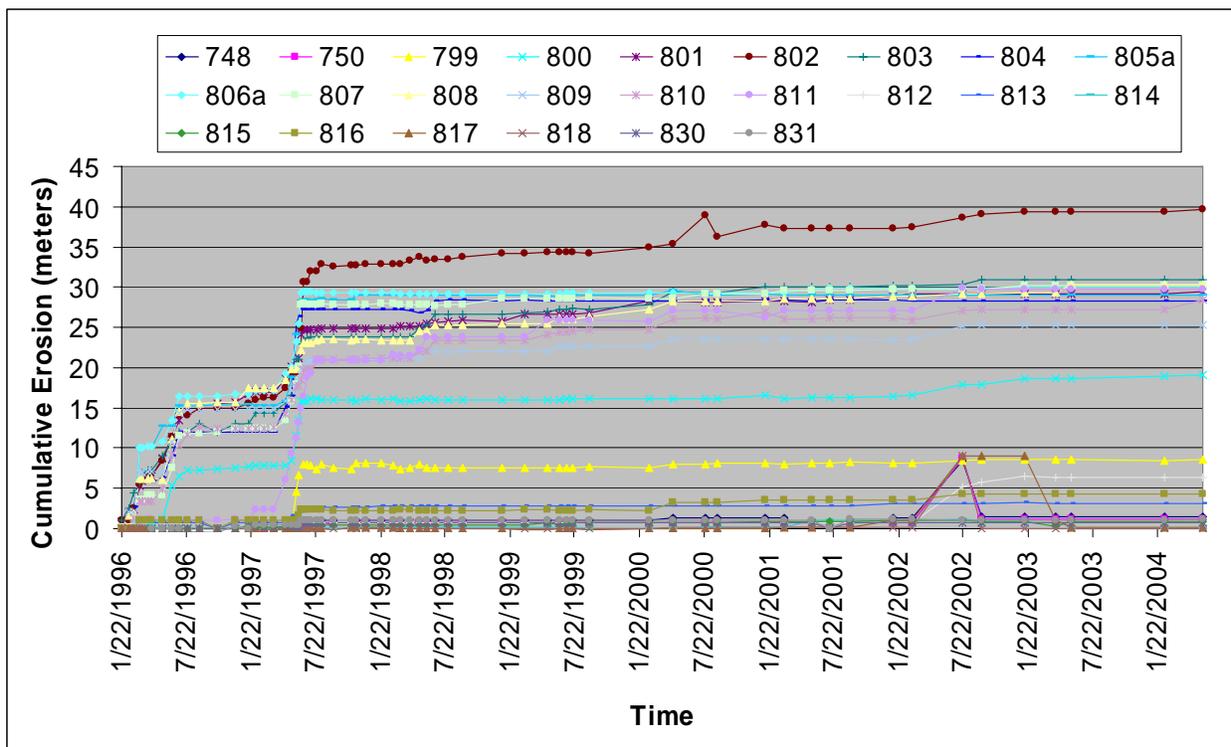
Figure 7. Cumulative Erosion at 21 Monitoring Stations on Locke Island Since January 1996

The timing and amount of erosion that has occurred at transects since January 1996 is shown graphically in Figure 7. This chart shows very rapid, intermittent recession of the northeast bank of Locke Island from the inception of monitoring (early 1996) through mid-summer of 1997. Since that time erosion has proceeded at a slow average rate. An exception is up to a few meters of erosion that occurred briefly in mid-June of 2002.

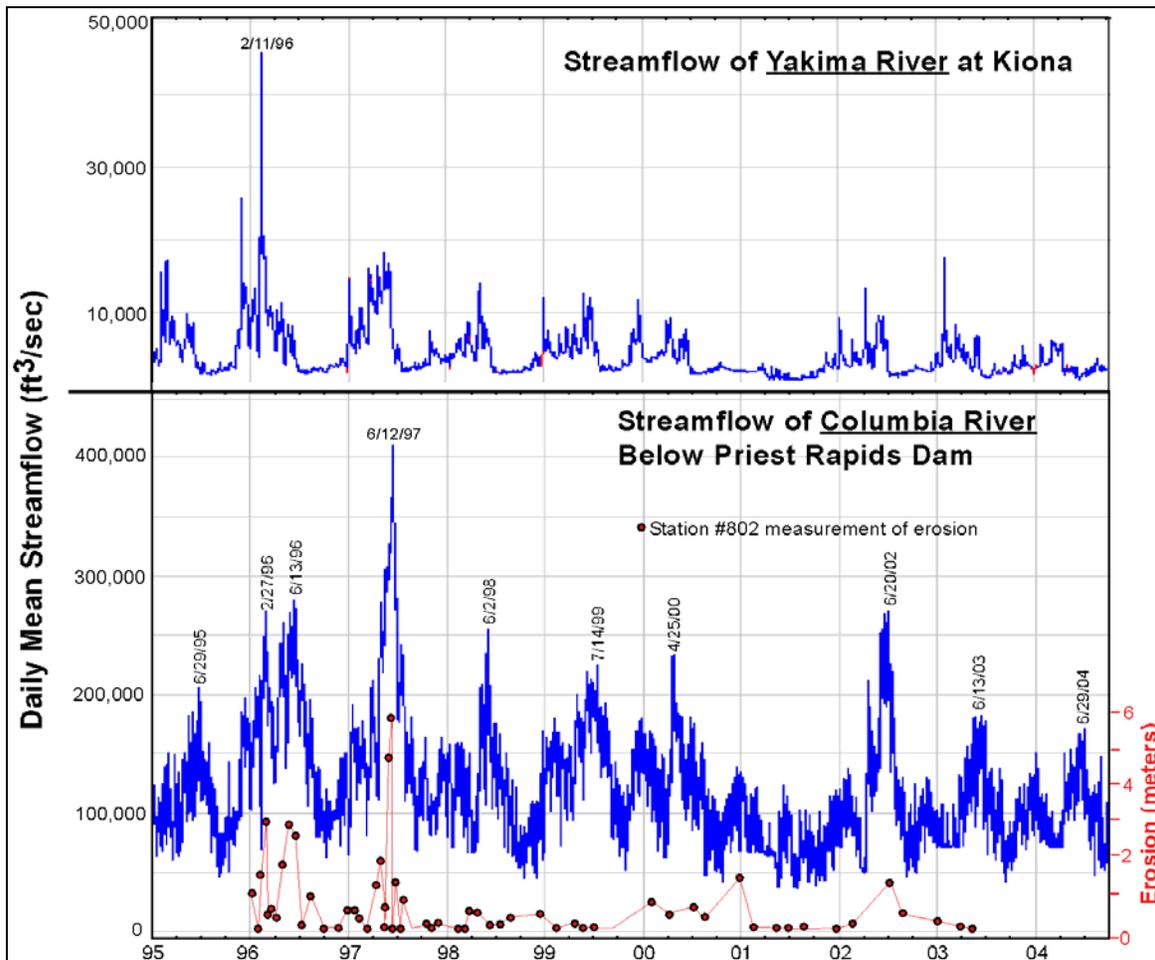
Figure 8. Plot Showing Correlation Between Columbia River Stream Flow and Erosion Measured at Locke Island (Natural flow of Yakima River shown at top.)

In Figure 8, the average daily stream flow of the Columbia River is plotted since 1995, just prior to installation of erosion-monitoring transects. The erosion observed at Station #802 (greatest amount of erosion measured) is plotted beneath stream flow. Figure 8 clearly shows a direct correlation between the amount of erosion and stream flow of the Columbia River below Priest Rapids Dam. Most of the highest stream flows from the Columbia River come in mid-to-late June during spring runoff and as Grand Coulee Dam releases the greatest amount of water from the upper Columbia River stored over the winter and spring.

Also from Figure 8, it appears that little or no erosion has occurred along Locke Island as long as stream flows are <200,000 cfs. The most erosion occurred in mid-June 1997 during a ~20-year flood when the river flowed at 400,000 cfs. At other times (e.g., 2/96, 6/96, 6/02) some erosion still occurred at 300,000 cfs. Historically, the Columbia River below Priest Rapids Dam has had flows $\geq 400,000$ cfs only once (6/97) in the last 30 years. Prior to the early 1970s, stream flow of the Columbia River below Priest Rapids Dam exceeded 400,000 cfs on a regular basis, exceeding 400,000 cfs at least a couple of dozen times since record-keeping began in 1917 (Figure 9). However, regulation of flow behind the dams since the 1970s appears to have kept flows under 400,000 cfs, except in rare instances like the June 1997 flood of the Columbia River. But even with this flow regulation, flows approaching 300,000 cfs, still powerful enough to produce erosion at Locke Island (see Figure 8), have occurred several times since the 1970s.

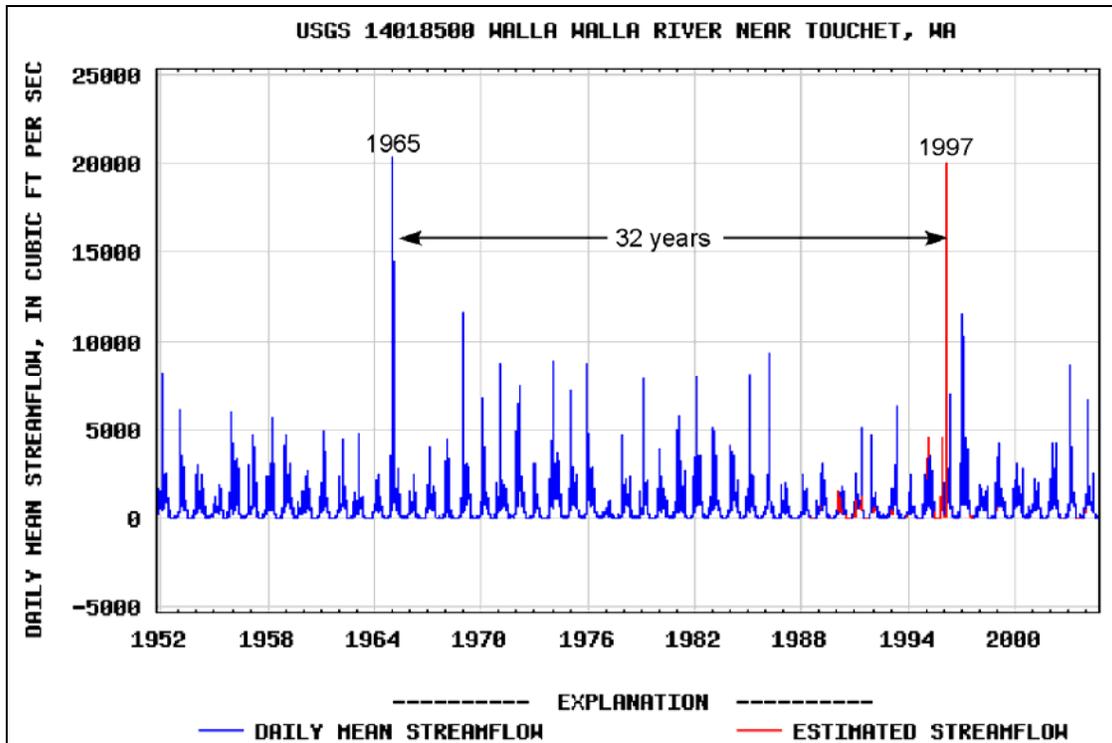
Figure 10. Peak Stream Flow of the Walla Walla River Since 1952 (Recurrence interval of 1996-1997 flood magnitude ~32 years.)

To determine the frequency of the major flooding events, like that which eroded Locke Island during 1996-1997, it is instructive to look at the flow of other rivers, unregulated by dams. For this exercise, two of the nearest rivers to the Columbia are examined: the Yakima and Walla Walla Rivers. Prior to the flooding of the Walla Walla River in 1997, the next earliest flood occurred 32 years earlier in 1965 (Figure 10). Yakima River peak flows, comparable to those of 1997, have occurred five times since 1906, a recurrence interval of 20 years (Figure 11).

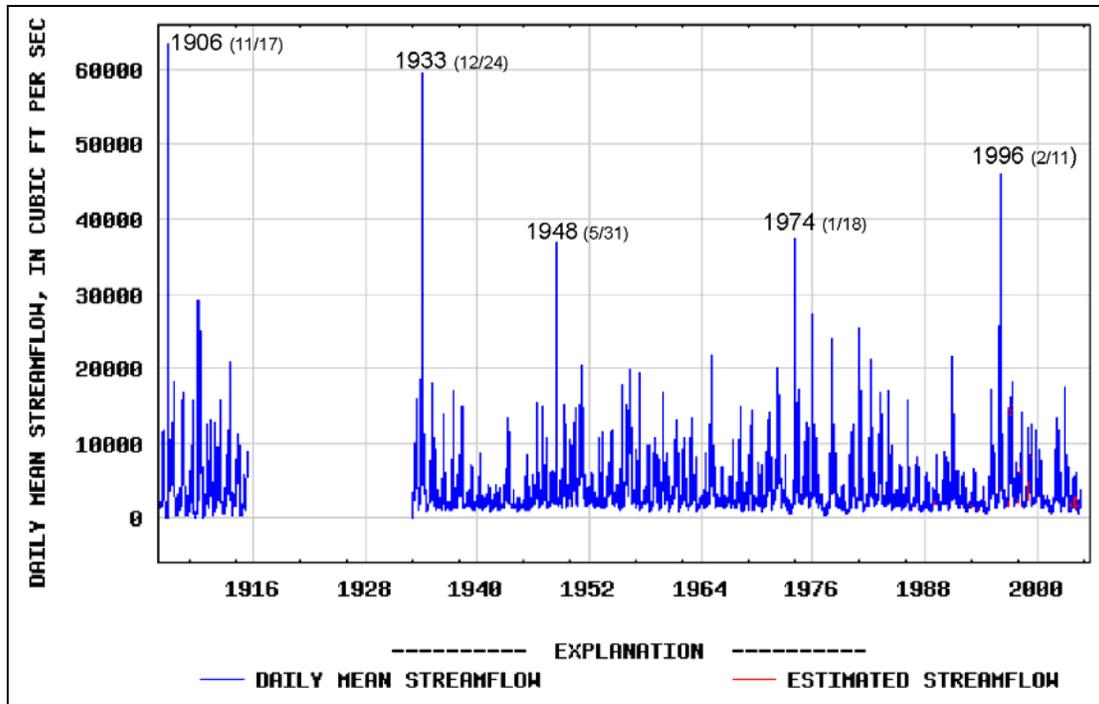
Figure 11. Peak Stream Flow of the Yakima River at Kiona Since 1905 (Recurrence interval of 1996-1997 flood magnitude ~ 20 years.)
